FIG. 1  
TEST REPORT

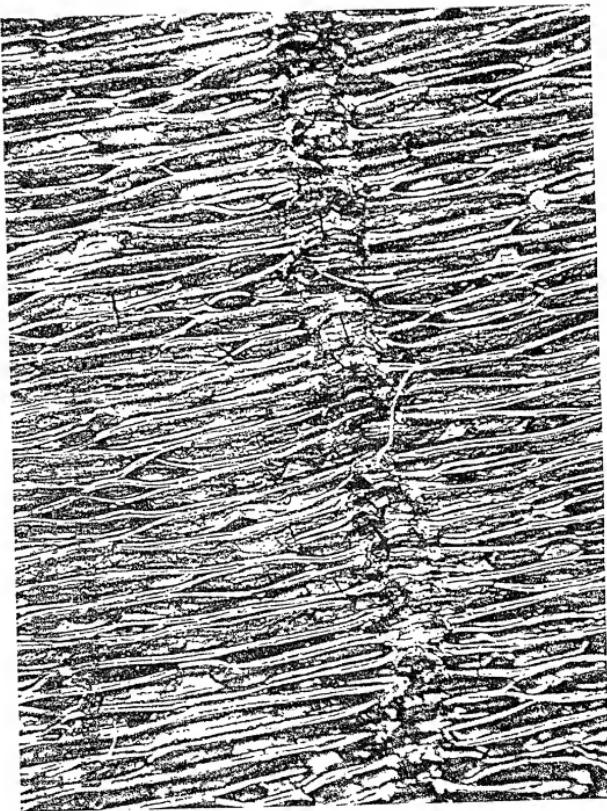
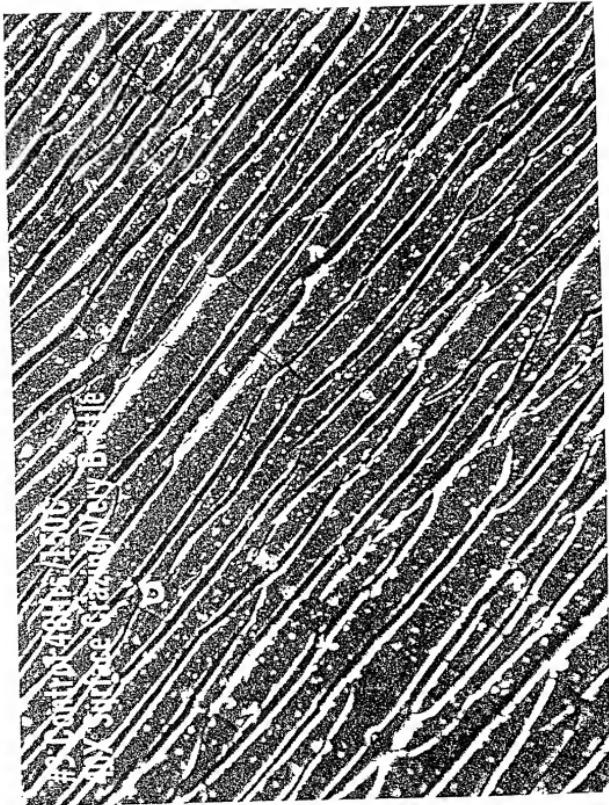
Sample #1 Surface at 40X After  
48 Hours at 150C

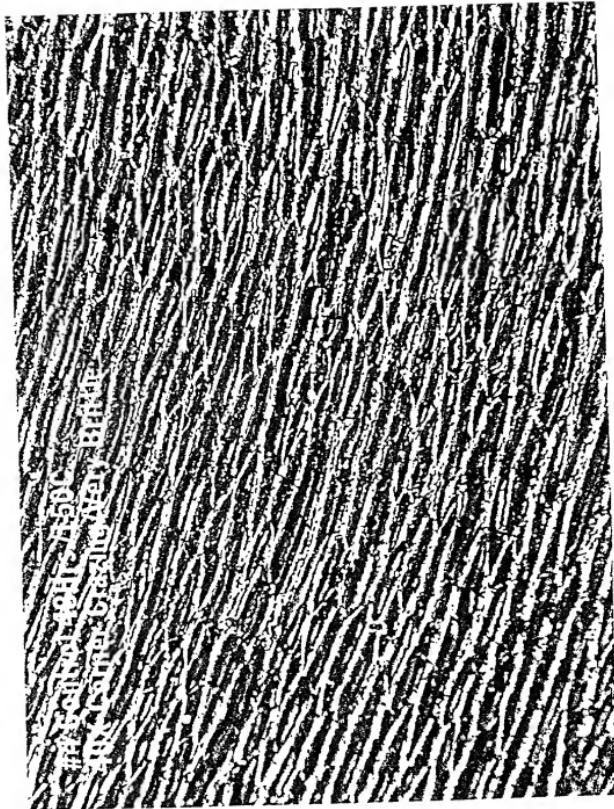
FIG. 5° 6 ASTEROID

Sample 4 Surface Photo 40X  
After 48 Hrs./150C
